RE: SHPO Case No. 16-1464
USFS, FS# 666EA0092A, Tilly Jane Ski Warming Hut
Preservation work on A-Frame
Forest Scervice Road 3512-630 (2S 9E 15), Hood River County

OREGON SHPO CLEARANCE FORM

A contributing element to the Cloud Cap-Tilly Jane Historic District, the Tilly Jane A-Frame, or Ski Warming Hut was constructed by the CCC's in 1939 and is the last addition to the Historic district. It is a one and one half story rectangular log A-frame building with a concrete foundation. It is on an east-west axis measuring 18 by 56 feet. The shake, gabled roof is built with log rafters that extend to the ground level forming the "A" shape. About half of these rafters are anchored on partially buried boulder abutments. The remaining foundations are concrete replacements installed in the early 1980's. The roof reaches the ground on the front 15 feet of the structure covering the vestibule. The exterior walls are all covered with shakes with the exception of the areas on either side of the vestibule, which are filled with vertical half-log siding (photo above). The fenestration of the building is regular, four-paned, fixed-wood sash windows. The exception to this is the nine-panel, fixed-wo

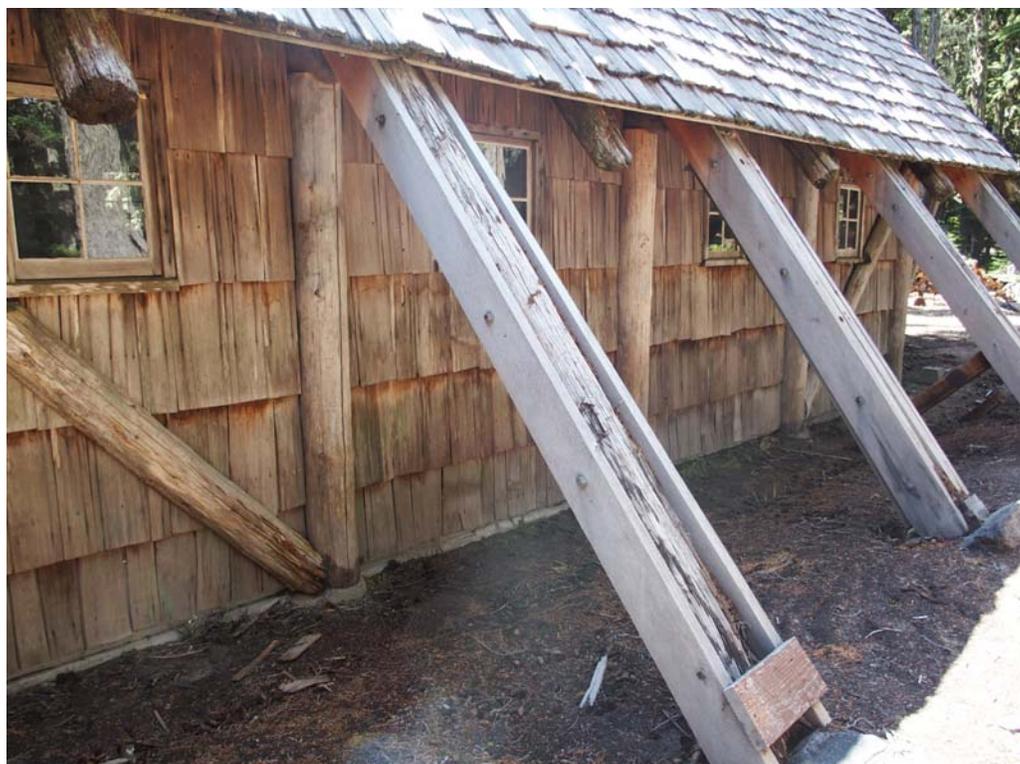
The project is to rehabilitate and stabilize the structure. The structure is unique for its buttress/rafters that extend from the roof peak to the ground to be anchored on partially-buried boulders. These prominent features are character-defining elements for the structure. Past changes to the structure in the 1970s includes the replacement of the boulder anchors with angled concrete forms faced with a masonry veneer on the south side (Figures 15), and replacement of deteriorated buttress/rafters with new material spliced to old material beneath the eaves (Figure 16). The buttress/rafters on the north side were not replaced but have severely deteriorated and have been largely replaced with 2" x 10" boards (Figures 10, 11 and 12).

Figure 10. Tilly Jane Ski Warming Hut. Photograph of deteriorated buttress/rafters on north elevation "sandwiched" between 2"x10" boards. USFS digital photograph obtained by Michael D. Dryden 07/18/2016.

This project proposes to restore the character-defining boulder anchors on the south side of the structure, replace the previously spliced buttress/rafters, and replace the deteriorated rafter/buttresses on the north side of the structure. The ground around the west side of the structure will be graded to drain water away from the building (see continuation sheets for additional details and discussion).

- The buttress/rafters on the north side of the structure have deteriorated significantly and lack structural integrity. These buttress/rafters will also be spliced up high under the eaves.

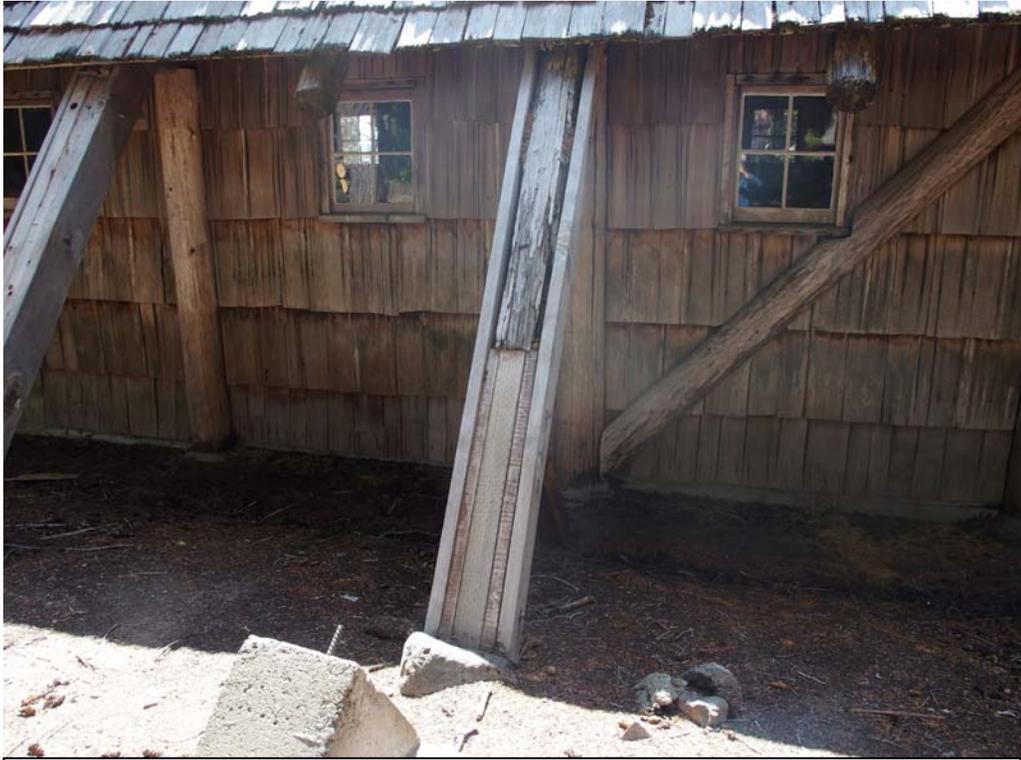
Figure 11. Tilly Jane Ski Warming Hut. Close-up view of deteriorated buttress/rafters on north side of structure with augmented timbers. USFS digital photograph obtained 07/18/2016

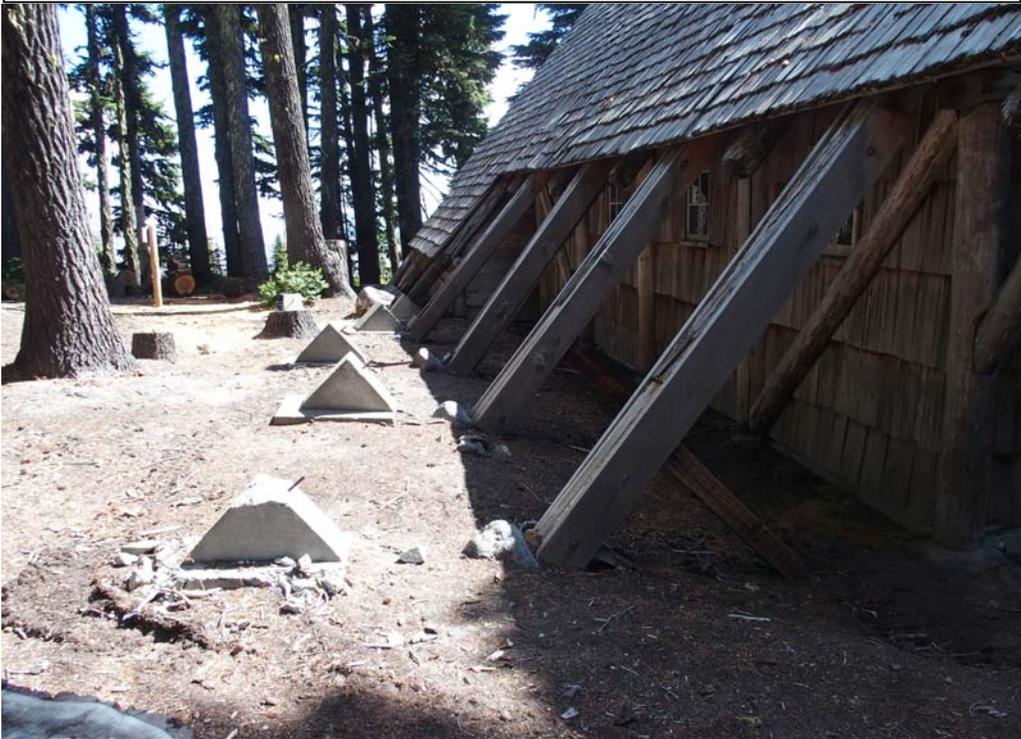
Figure 12. Tilly Jane Ski Warming Hut. Overview of rafter/buttresses on north side, view looking east. Concrete forms intended to replace boulder anchors situated to left of buttress/rafters. USFS digital photograph obtained 07/18/2016.

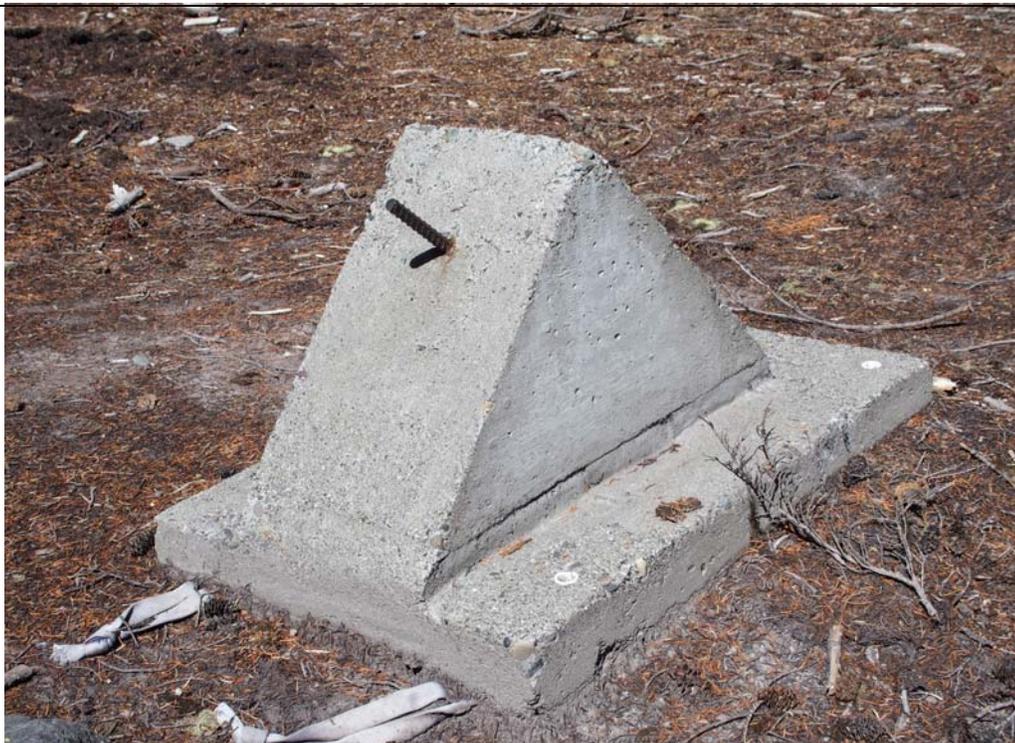
Figure 13. Tilly Jane Ski Warming Hut. Close-up view of concrete form intended to replace boulder buttress/rafter anchors. USFS digital photograph obtained 07/18/2016 by Michael D. Dryden.

- The existing non-original concrete forms on the south side of the structure would be removed.
- The existing original anchor boulders on the north side of the structure would be left in place and reused.

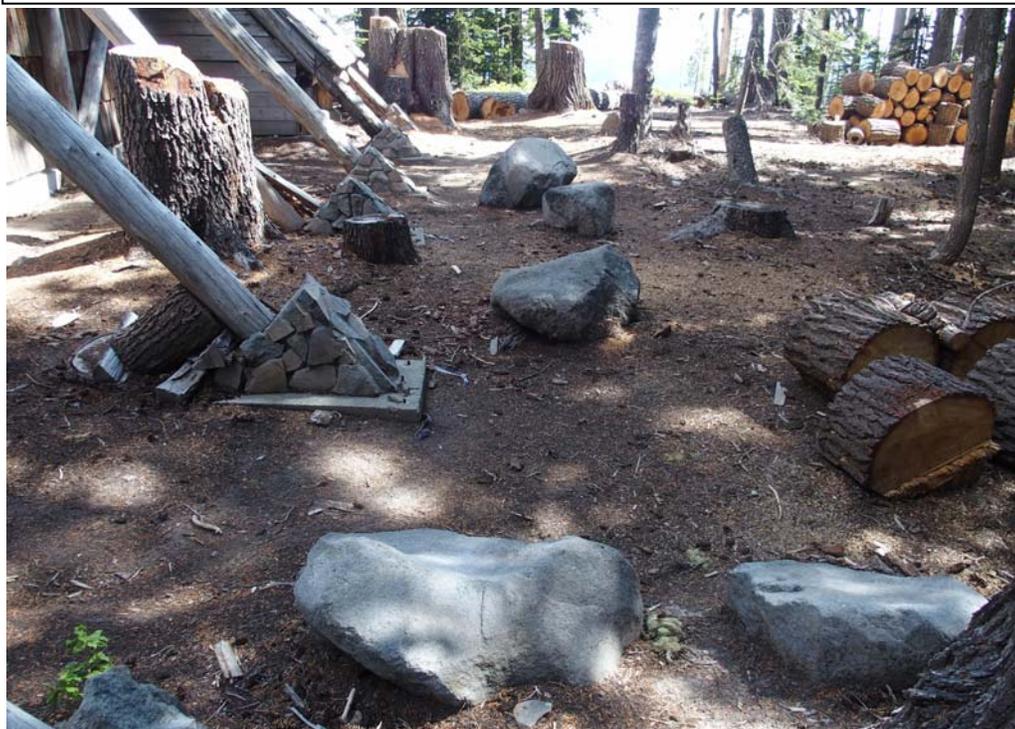
Figure 14. Tilly Jane Ski Warming Hut. View of buttress/rafters and boulder anchors replaced on south elevation. View looking east. The previous boulder anchors lie just to the right of the buttress/rafters. USFS digital photograph obtained 07/18/2016 by Michael D. Dryden 07/18/2016.

- The buttress/rafters and their boulder anchors are defining characteristics for the structure. The concrete anchors that replaced the boulders on the south side of the structure will be removed, and the original boulder anchors will be restored. The boulder anchors on the north side of the structure will be left in place.

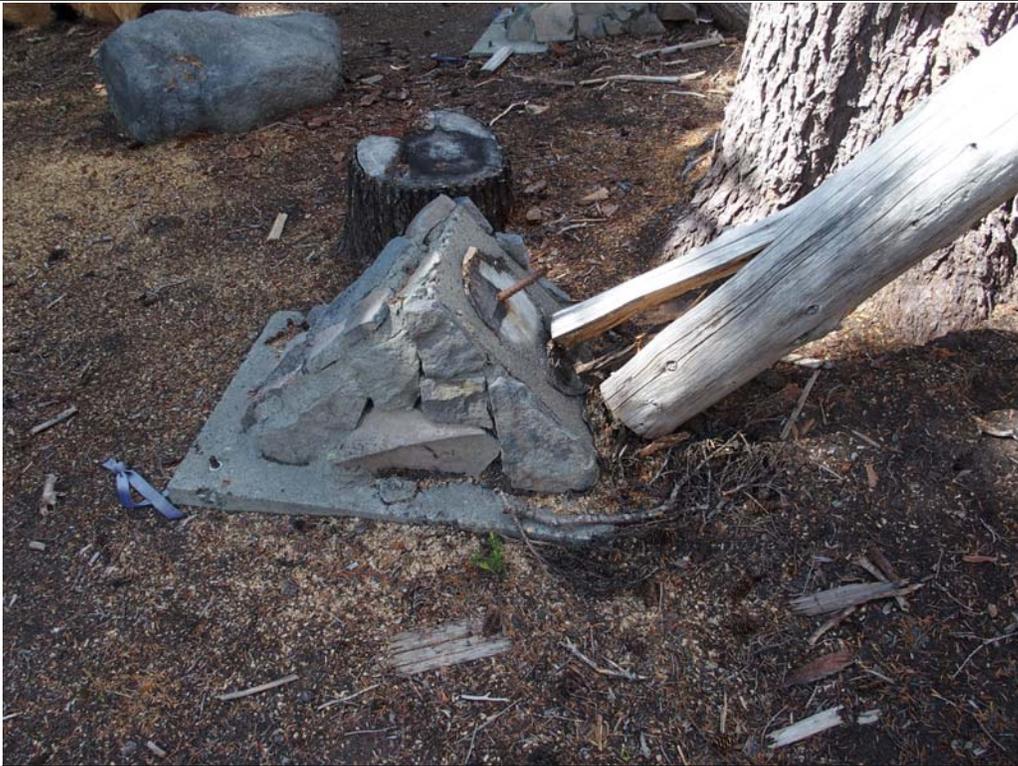
Figure 15. Tilly Jane Ski Warming Hut. Close-up view of concrete buttress/rafter anchor replacement with masonry veneer. USFS digital photograph obtained 07/18/2016.

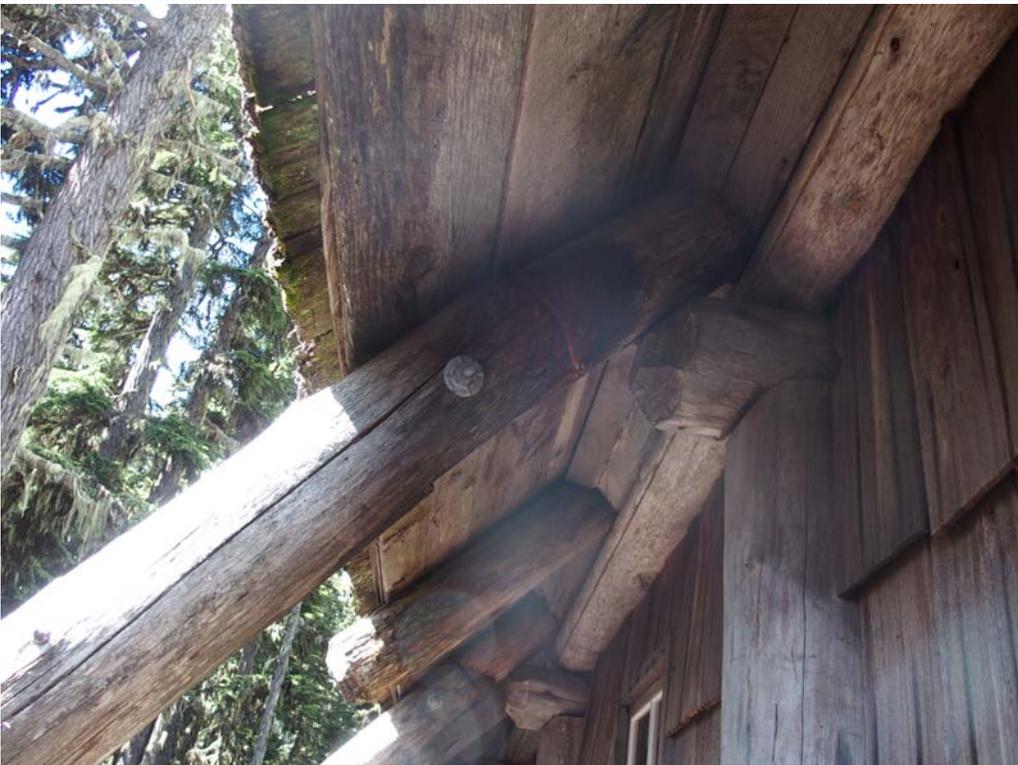
Figure 16. Tilly Jane Ski Warming Hut. View of previously-spliced buttress/rafter situated on south elevation. USFS digital photograph obtained 07/18/2016 by Michael D. Dryden.

- The previously spliced buttress/rafters would be removed.
- Holes measuring approximately two feet square and two feet deep would be excavated.
- The holes would be filled with $\frac{3}{4}$ minus gravel and compacted.

- The buttress/rafters on the south side of the structure have been previously replaced. Replacing these features will not affect historic materials. However, a small portion of the existing buttress/rafters will be cut to enable placement the new splice higher under the eave where it will be more protected from the elements and will not wick moisture into the splice. The splice bolt heads will be counter-sunk and not visible to the casual observer.

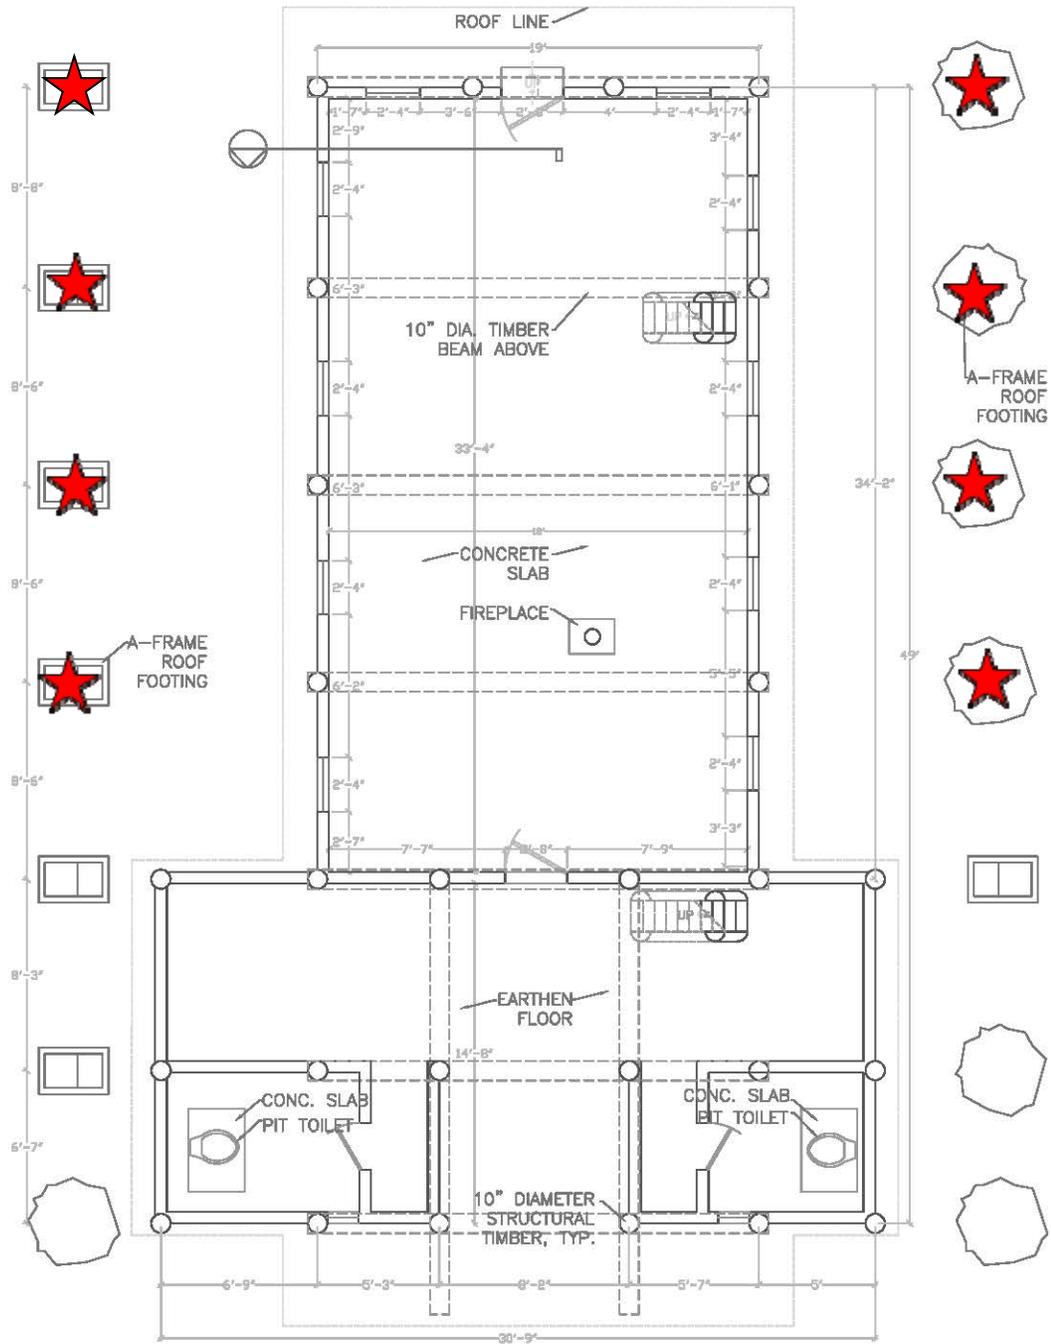
Figure 18. Tilly Jane Ski Warming Hut. Plan view; butters/rafters proposed for replacement are indicated by red star. Boulders on right side of building will be undisturbed and used in place. Drawing by Andrew Houlihan.

The buttress/rafter boulder anchors left in place on the north side of the structure were found to be solidly positioned and will be left in place. The project proposes to restore four of the buttress/rafter boulder anchors on the south elevation and to splice four replacement buttress/rafters on the north elevation (Figure 18).

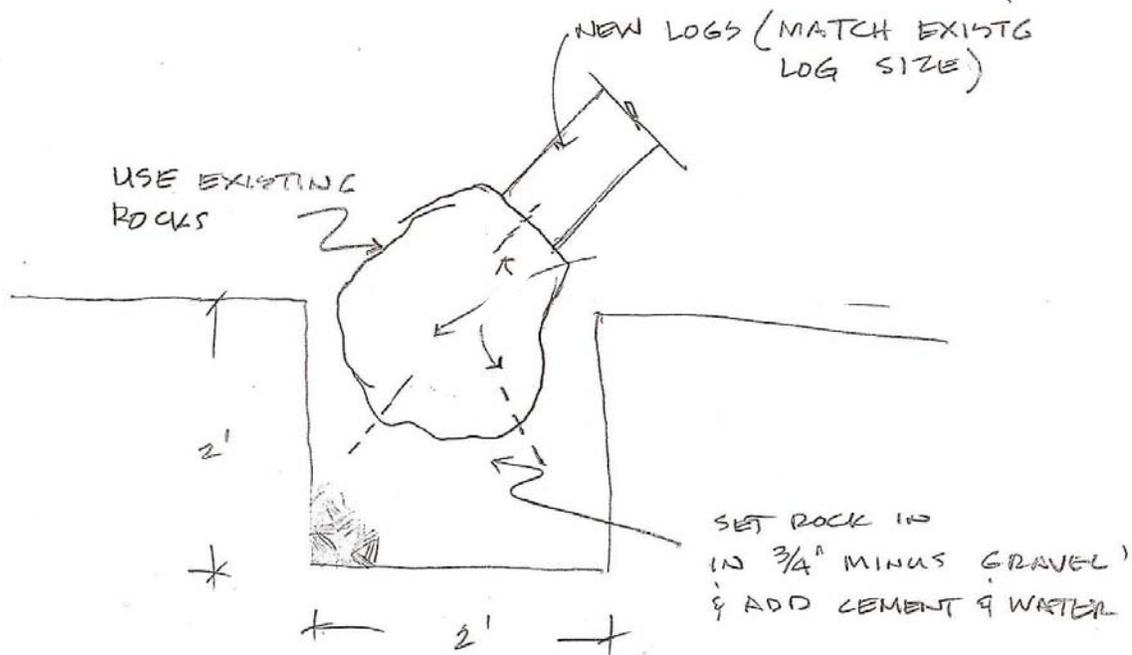
Figure 19. Drawing of proposed buttress/rafter boulder anchor restoration. Drawing by Wells Construction, Inc.

- Quikrete concrete mix would be added to the gravel.
- The original boulder buttress/rafter anchors would be placed atop the gravel/concrete mix in each hole (Figure 19). The boulders would be reburied but partially exposed.

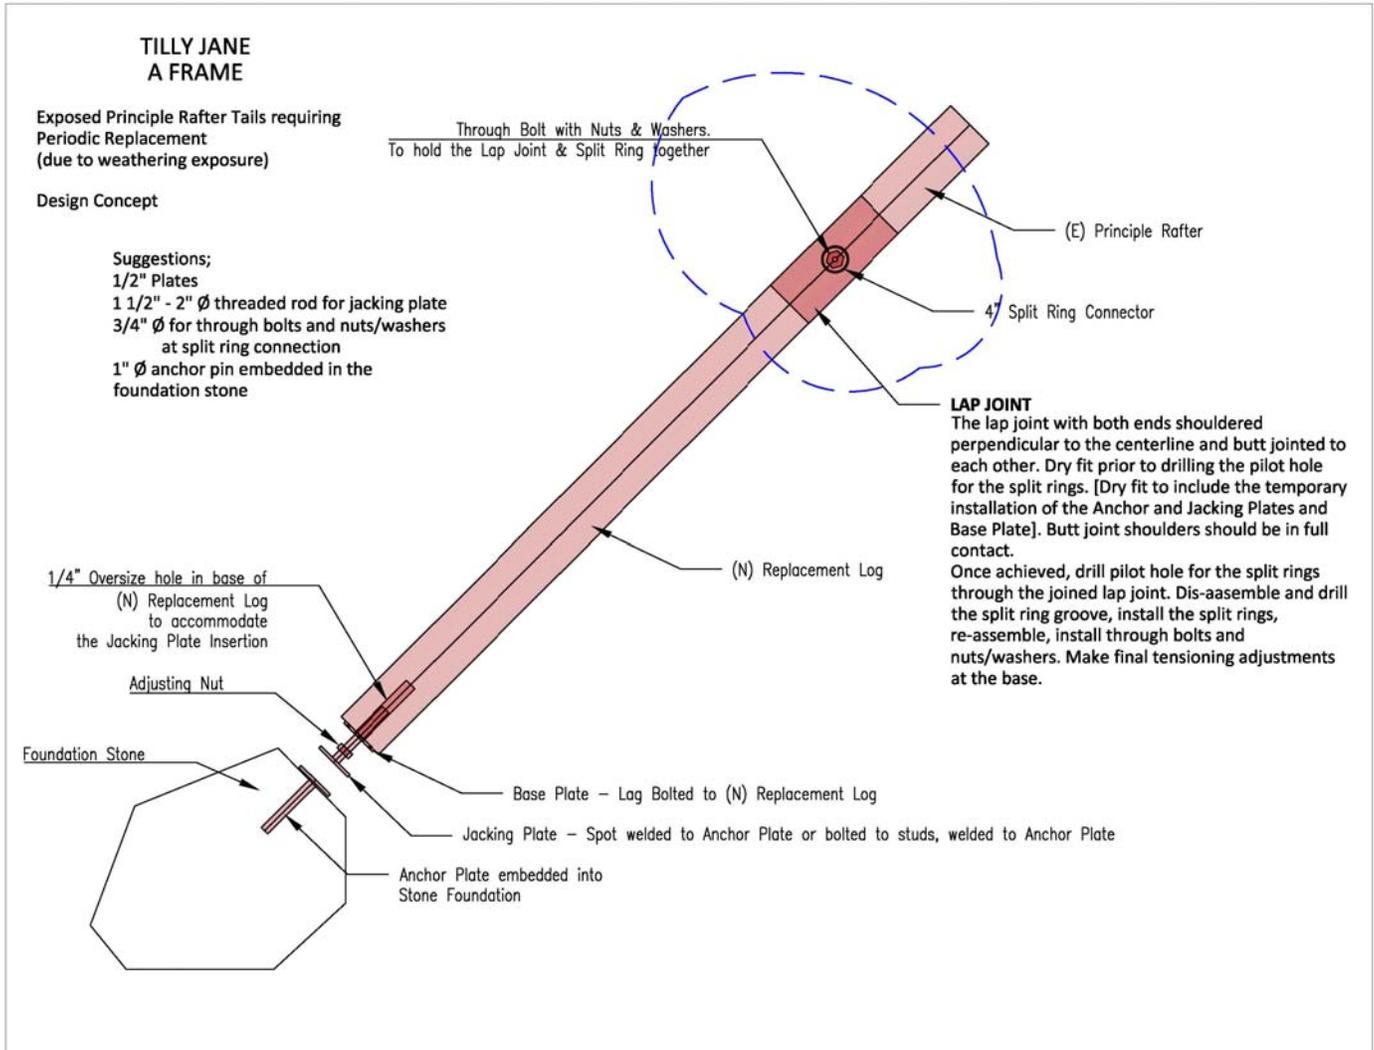
Figure 20. Tilly Jane Ski Warming Hut. Diagram of proposed connection between rafter/buttress log and anchor boulder. The base plate, jacking plate, anchor plate, and the adjusting nut would not be visible to the casual observer. The adjusting nut and base plate could be tightened as the wood shrinks and the anchor boulder settles to provide for a solid connection. The space would also provide for air space between the base of the log and the boulder and prevent dry rot. Drawing by David C. Rogers of Logs and Timbers, LLC.

- It was determined that the original log-to-boulder connection lacked stability. The threaded rod and base plate connections will provide a solid, stable connection. The connection will also provide air space and allow water to drain, and will prevent dry rot. The connection can also be tightened as needed to provide for a solid joint. The connection will also not be visible to the casual observer.

- A hole would be drilled in each boulder anchor. Anchor pins 1" diameter would be epoxied into the drilled holes. A $\frac{1}{2}$ " anchor plate would be attached to the end of the anchor pin flush with the face of the anchor boulder (Figure 20).

- A $1\frac{1}{2}$ " to 2" threaded rod would be inserted into the base of the replacement buttress/rafter. A $\frac{1}{2}$ " thick base plate would be tightened against the base of the replacement log. A $\frac{1}{2}$ " jacking plate would be attached to the end of the threaded rod, and an adjusting nut would be situated between the jacking plate and the base plate (Figure 20). The jacking plate would be spot welded to the anchor plate. The adjusting nut would be used to tighten the connection as needed.

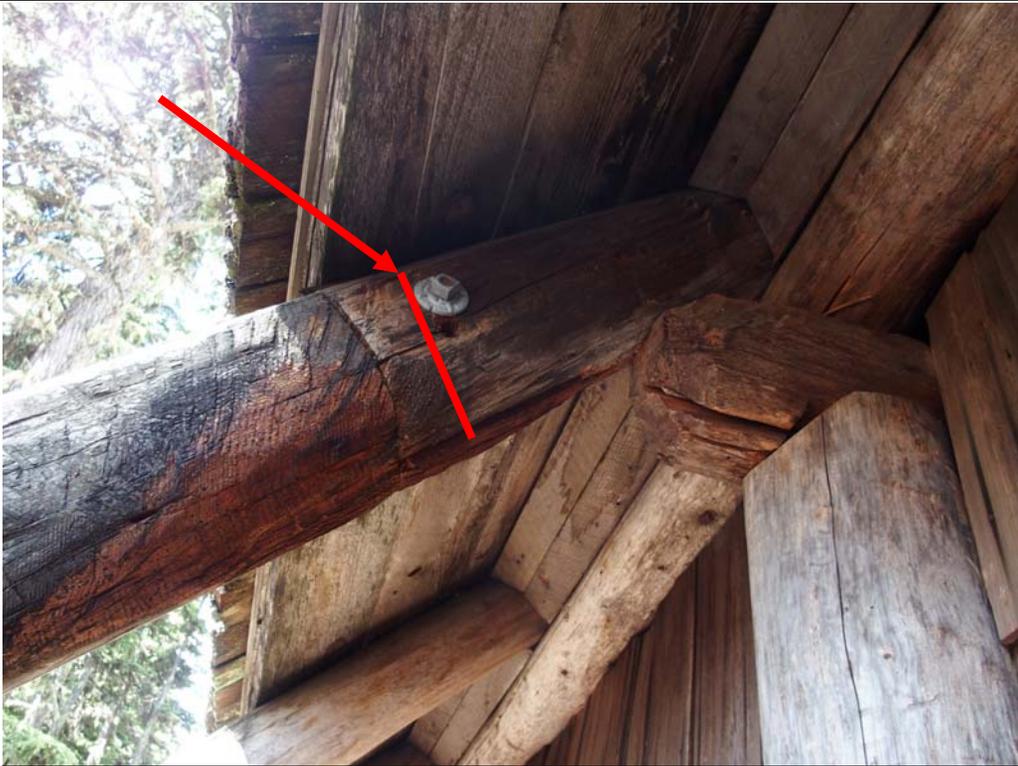
Figure 21. Close-up view of previously spliced buttress/rafter on south elevation. The location of the current splice tends to wick moisture up into the splice. The new splice would be situated 2" to 3" higher under the eave to be more protected. Red arrow points to the proposed splice location. USFS digital photograph obtained 07/18/2016.

- Logs of Pacific Silver Fir and hemlock would be selected for the appropriate diameter for half-lap splicing onto the original buttress/rafter (Figures 21 and 22).

- The replacement buttress/rafters would be secured with $\frac{3}{4}$ " bolts situated at the splice. The bolt heads would be counter-sunk to show less. The bolts would be an unobtrusive color, either black or rust-colored.
