Tilly Jane-Legion Camp Area: Many of the currently used public recreation facilities are part of this area. This portion of the Historic District was developed within the historic context of the Motor Age in the 1920's and 30's on the banks of Tilly Jane Creek. The development focused around a general public recreation use of the area. The Legion Camp on the east side of Tilly Jane Creek provided an annual sponsored, guided, climb of Mt. Hood that was open to the general public. The Tilly Jane campground was a free use campground open to the general public. The Tilly Jane Guard Station provided Forest Service presence during the recreation seasons. The Ski Warming Hut added by the CCC's provided winter accommodations for the general public, making the area usable year round. Only the southern foundation of the cableway across Tilly Jane Creek remains.

Tilly Jane A-Frame: A contributing element to the Cloud Cap-Tilly Jane Historic District.

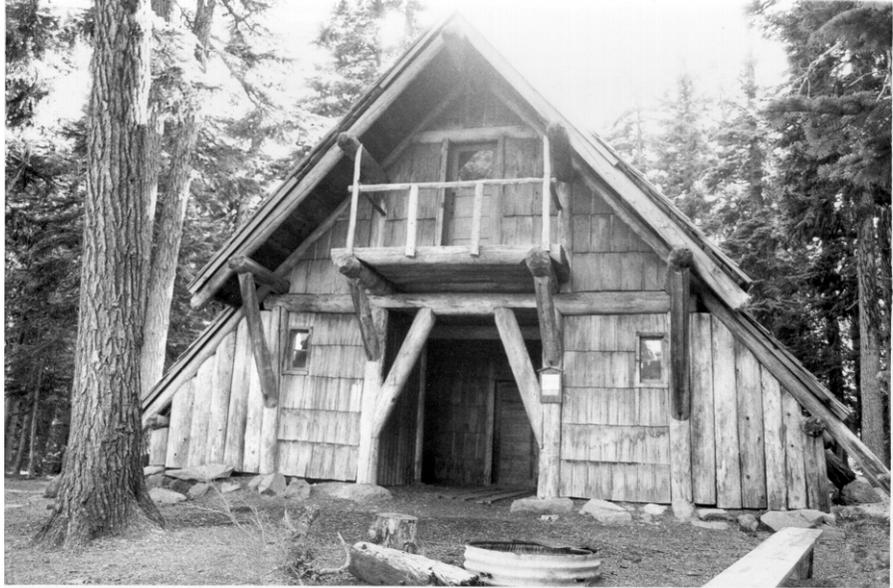
structure covering the vestibule. The exterior walls are all covered with shakes with the exception of the areas on either side of the vestibule, which are filled with vertical half-log siding (photo above). The fenestration of the building is regular, four-paned, fixed-wood sash windows. The exception to this is the nine-panel, fixed-wood sash window looking out from the upstairs loft above the rear entrance.

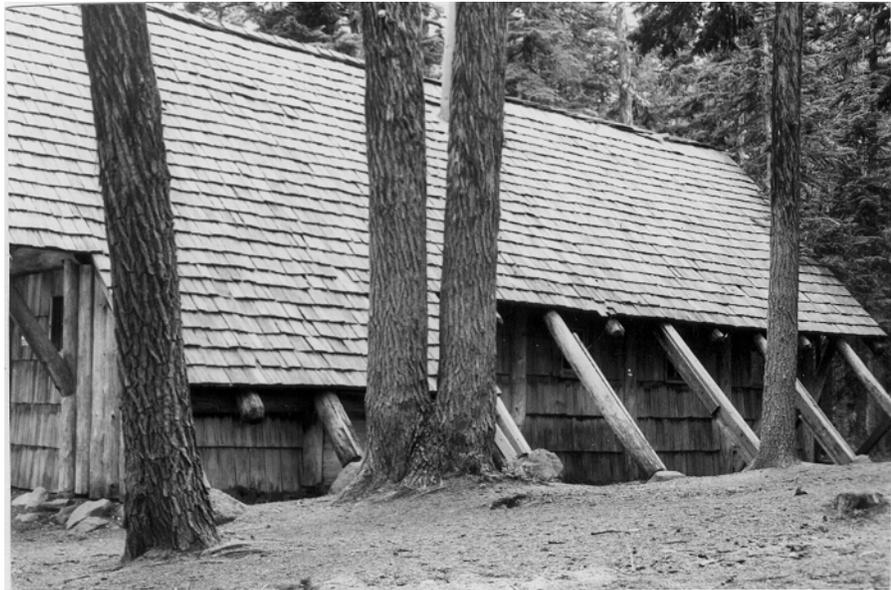
Existing Condition: The A-frame shelter is in fair shape; however, the sleeping loft is showing signs of age and the supporting joists are on four-foot centers. The old loft floorboards and wide span results in sagging and a feeling of insecurity. The exposed portions of many of the buttresses have rotted. Some have been strengthened by the addition of 2x6 boards

(see photo right). A modern door has been used to replace the balcony door on the main elevation. Of the two toilet areas in the original design, one is used for wood storage and the other is non-standard barrel toilet. A number of trees are growing next to the structure. Their branches are rubbing against the building resulting in abrasion and loss of shingles. Their roots have the potential to impact the buildings foundation. Many of the vertical support posts are in contact with the ground, and the bases of the posts show 4" to 10" of deterioration. Many of the exposed rafter and purlin ends are exposed to the elements and also exhibit decay. The north balcony shows varying degrees of deterioration, and the existing rail system is inadequate. Some of the exterior wall shakes show deterioration from ground contact and from birds boring for insects.

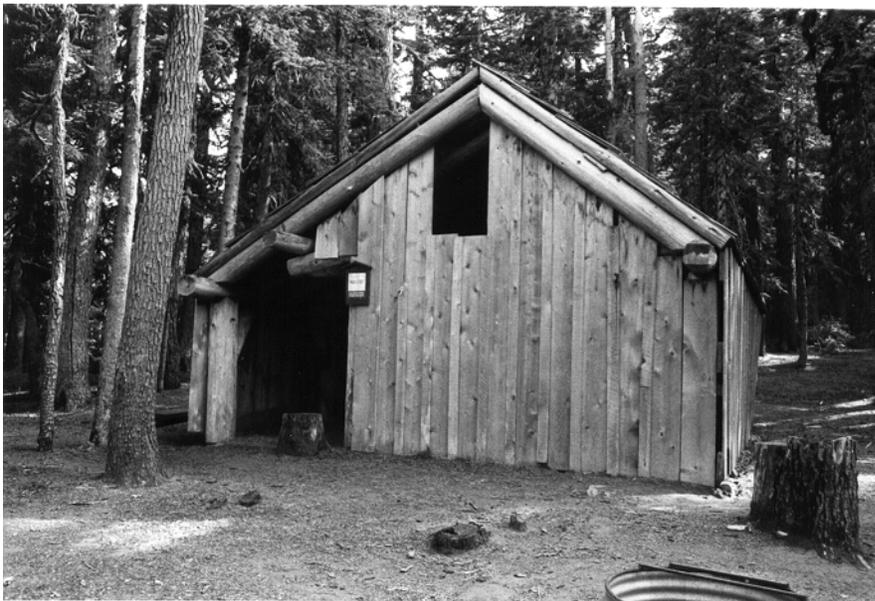
Cookhouse 1982, note the entrance had a door added during the early 1980's

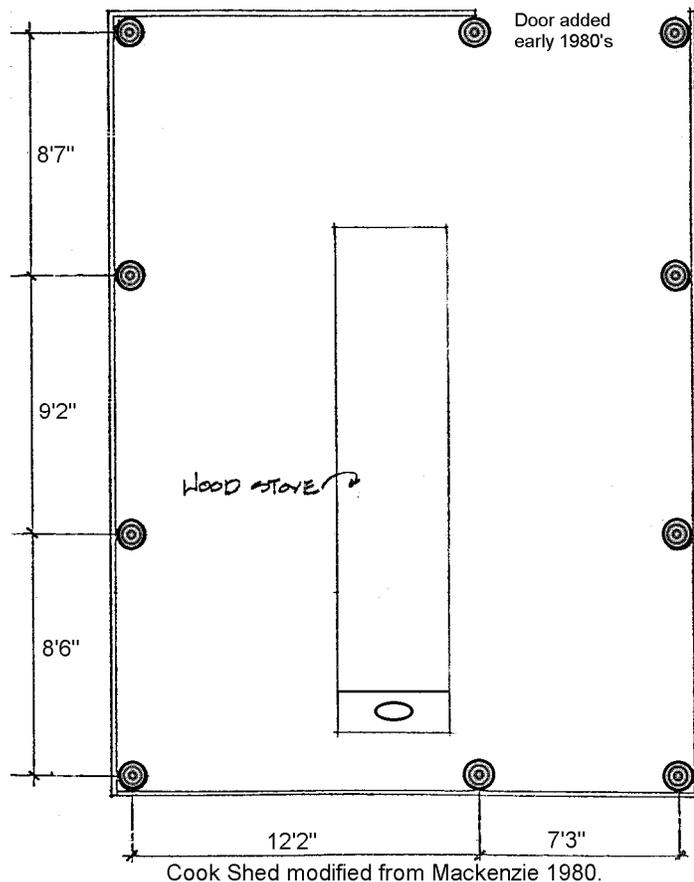
Existing Condition: The Cookhouse is in a deteriorating condition. Because of contact with the ground and a lack of ventilation, the lower one to two feet of the walls are decaying. The log header at the entrance end is broken and has been wired together. Wind has removed some of the shingles, which have been replaced with plywood boards. A modern door was added during the 1980's. It is not in keeping with the style of the structure. There is no interior lighting or ventilation. A number of small trees have grown near the building. These have increased the shade and their needle drop has increased the moisture retention in the roof materials.

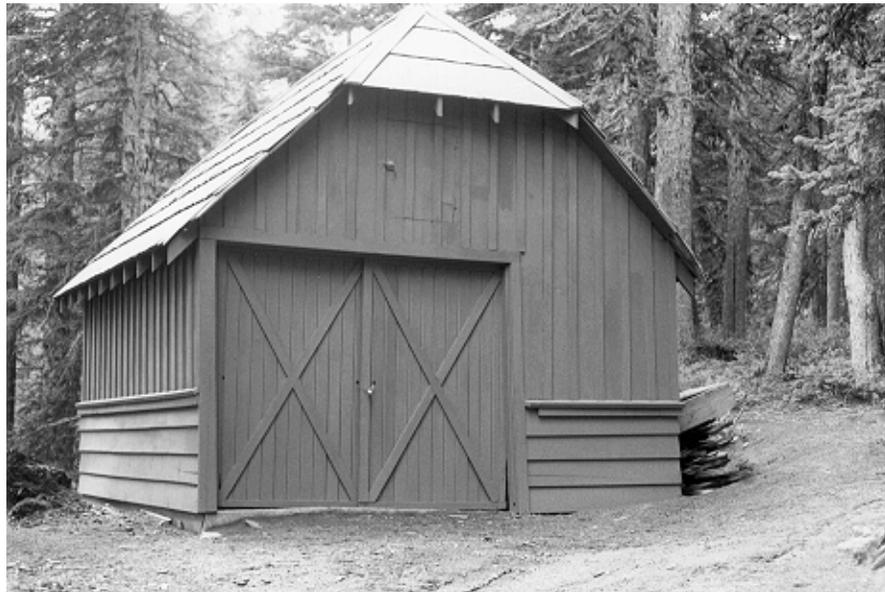
Tilly Jane Guard Station Garage

Existing Condition: The Guard Station is in good physical condition. The structure is in need of painting, and portions of the siding are in need of repair. Forest litter and debris, along with rain runoff tends to collect around the foundation of the structure. The northeast corner foundation of the garage is crumbling and needs to be repaired or replaced. Other needs include a chimney fire/spark screen and window screens.
