Tilly Jane A-Frame Project List

Structure Stabilization Projects

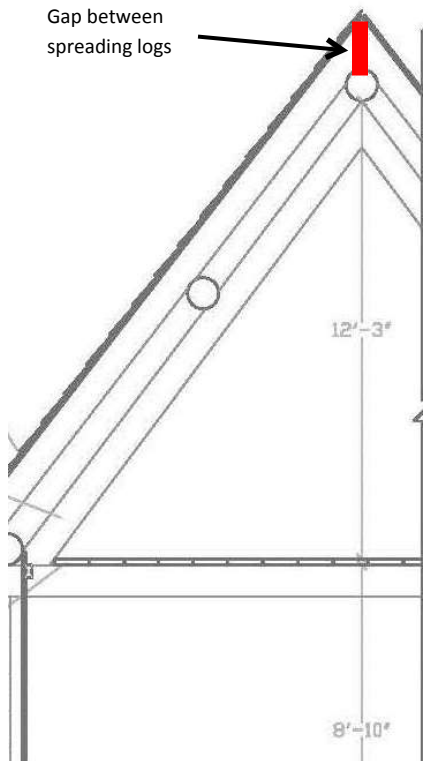
Figure 2. Log spread at gable apex.

Stabilize spreading logs at gable apex (Figure 2) with a gusset plate and threaded rods. Gusset plate and rods should be unobtrusive; black or rust colored. Threaded rods to travel through roof into logs.

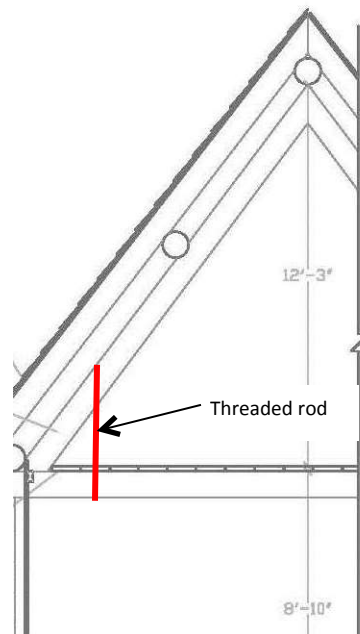
Loft flooring should be improved. Beams are not adequate for the span to support existing floor and people loading.

Figure 3. Beam support placement.

Add 5/8" threaded rods with large washers and nuts or other supports attached to rafter and beam (Figure 3).

Reinforced attachments should be placed 3-feet out from each end of beams.

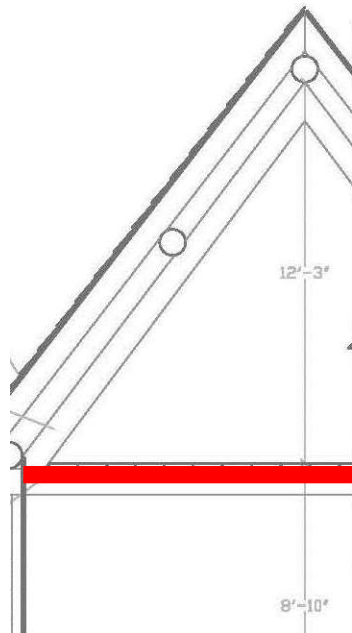
Figure 4. Floor support board shown in red.

Secure floor support (2"x6") to beam (Figure 4) with lag bolts or similar screws (see Appendix A)

Cut off newer floor boards (non-T&G) to butt against existing T&G flooring and be supported on newly added floor supports attached to beams.
