USFS, Mt. Hood NF, Project #2017-060606/004, Tilly Jane A Frame Warming Shelter Security Gate Addition
Add steel gate withing
Forest Service Road 3512-630 (2S 9E 15), Hood River County

OREGON SHPO CLEARANCE FORM

Property Name: Tilly Jane Ski Warming Hut (A-Frame) – FS Temporary Number 666EA0092A

Project Name: Tilly Jane A-Frame Security Gate Addition

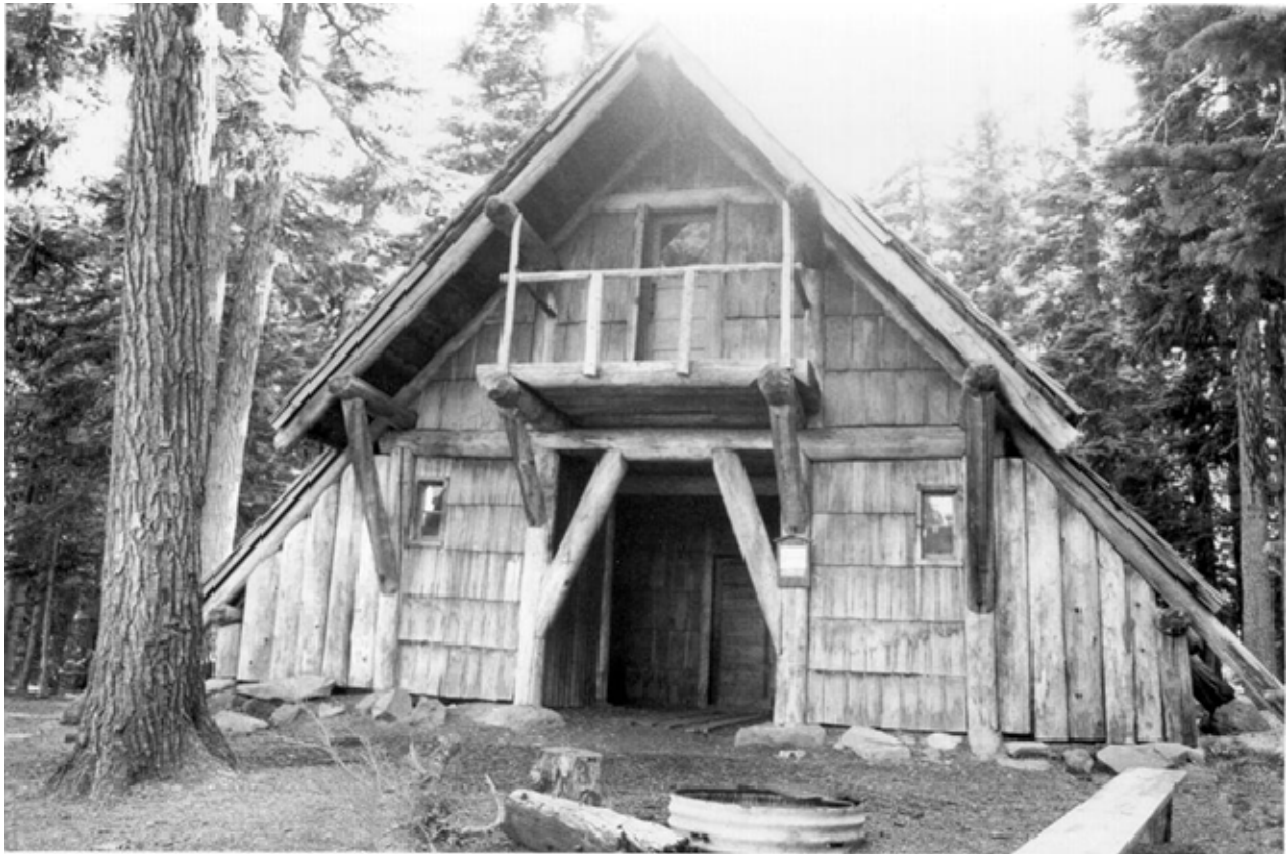
Figure 1. East elevation, Tilly Jane Ski Warming Hut (A Frame). Undated USFS photograph.

A contributing element to the Cloud Cap-Tilly Jane Historic District, the Tilly Jane A-Frame, or Ski Warming Hut was constructed by the CCC's in 1939 and is the last addition to the Historic district. It is a one and one half story rectangular log A-frame building with a concrete foundation. It is on an east-west axis measuring 18 by 56 feet. The shake, gabled roof is built with log rafters that extend to the ground level forming the "A" shape. About half of these rafters are anchored on partially buried boulder abutments. The remaining foundations are concrete replacements installed in the early 1980's. The roof reaches the ground on the front 15 feet of the structure covering the vestibule. The exterior walls are all covered with shakes with the exception of the areas on either side of the vestibule, which are filled with vertical half-log siding (photo above). The fenestration of the building is regular, four-paned, fixed-wood sash windows. The exception to this is the nine-panel, fixed-wood sash window looking out from the upstairs loft above the rear entrance.

The vestibule leading to the main entrance on the east elevation is 15 feet deep, has a dirt floor and contains toilets on either side. A steep stairway on the north side leads up inside to the loft and out through a door onto a pole railed balcony. The main room has a cement slab floor and is finished with vertical board walls. A large open circular fireplace was replaced in the early 1980's by a wood stove. The upstairs loft area has nearly as much floor space as the room below. The loft floor is made of large planks and the ceiling is open-log beamed. There is a steep ladder connecting the main floor with the loft.

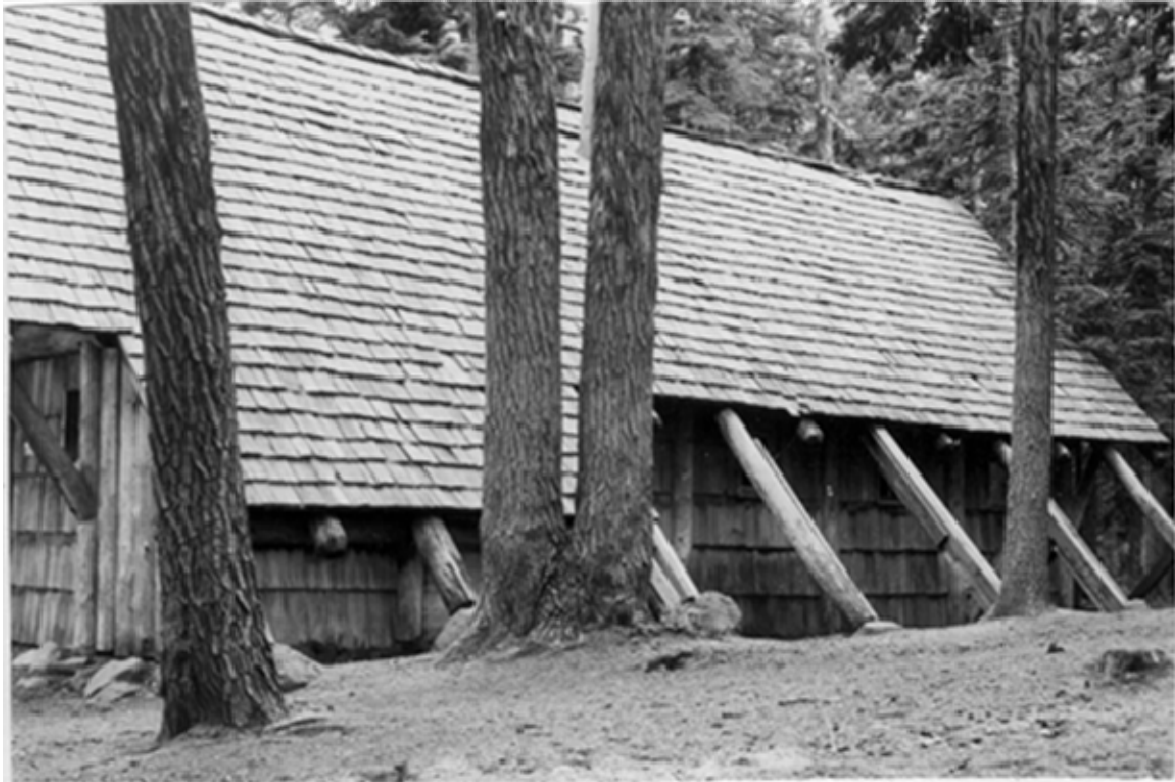
Figure 5. North elevation Tilly Jane Ski Warming Hut (A Frame). Undated USFS photograph.

The Character Defining Exterior Elements of the Tilly Jane A-frame include: the unique ridge to ground rafters and boulder abutment system; the cedar shake roof shingles; the double coursed cedar shake siding; the split log siding on the entry vestibule; the single pane, true-light sash window units; the exposed purlins; the T-shaped architectural plan; the exterior log support brackets; and the second floor north balcony arrangement.

Existing Condition: The A-frame shelter is in fair shape; however, the sleeping loft is showing signs of age and the supporting joists are on four-foot centers. The old loft floorboards and wide span results in sagging and a feeling of insecurity. The exposed portions of many of the buttresses have rotted. Some have been strengthened by the addition of 2x10 boards (Figures 10, 11 and 12). A modern door has been used to replace the balcony door on the main elevation. Of the two toilet areas in the original design, one is used for wood storage and the other is non-standard barrel toilet. A number of trees are growing next to the structure. Their branches are rubbing against the building resulting in abrasion and loss of shingles. Their roots have the potential to impact the buildings foundation. Many of the vertical support posts are in contact with the ground, and the bases of the posts show 4" to 10" of deterioration. Many of the exposed rafter and purlin ends are exposed to the elements and also exhibit decay. The north balcony shows varying degrees of deterioration, and the existing rail system is inadequate. Some of the exterior wall shakes show deterioration from ground contact and from birds boring for insects. All of the buttress/rafters on the north side have been replaced in the 1970s; the proposed project would replace non-historic materials on that side of the structure. The inspection of the structure by a regional Forest Service engineer Steven Oravetz revealed that all of the buttress/rafters on the south side of the structure have severely deteriorated and no longer retain any structural strength or stability and should be replaced.

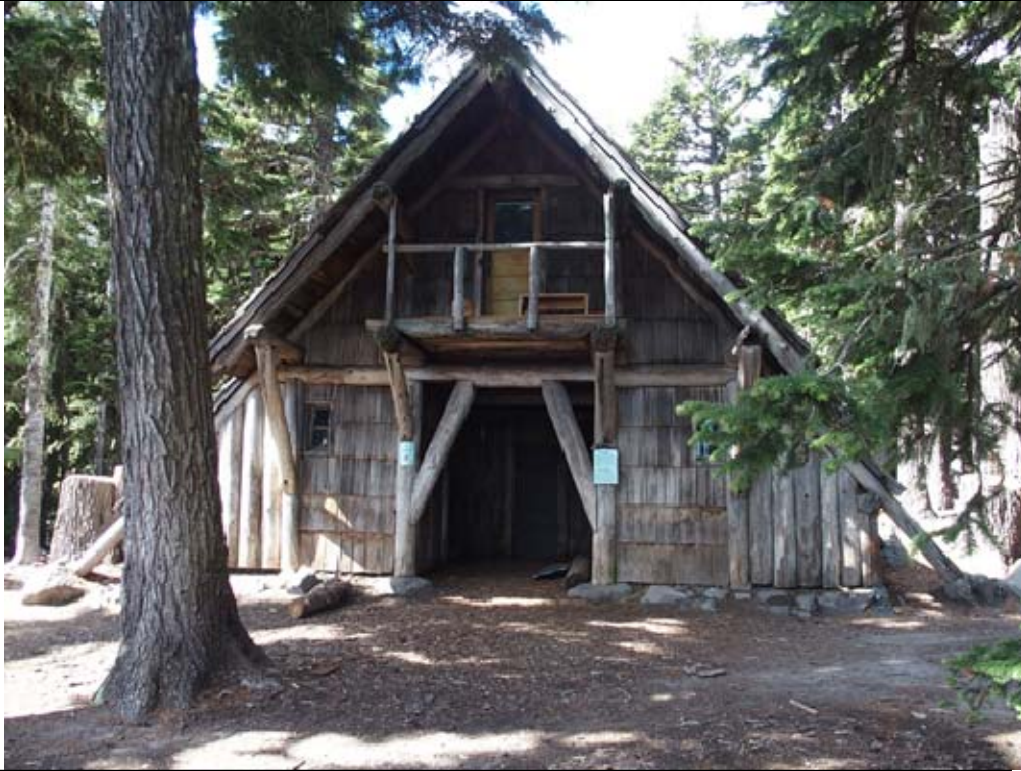
Figure 7. Tilly Jane Ski Warming Hut, east elevation showing entrance vestibule (front). USFS digital photograph obtained by Michael D. Dryden 07/18/2016.

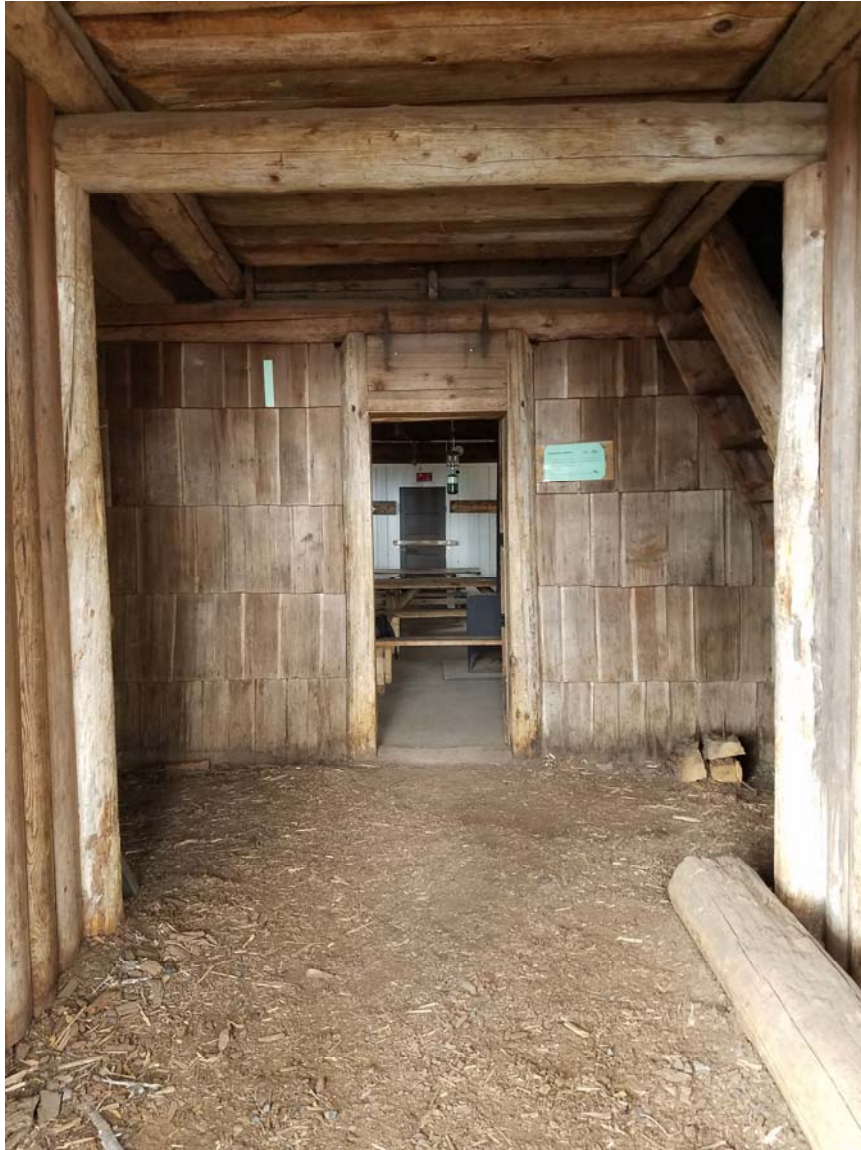
Figure 9. Entrance vestibule showing opening where proposed steel security gate would be attached to support posts. USFS digital photograph obtained by Michael D. Dryden 07/18/2016.

- The proposed security gate will be attached to the existing wood support posts and entry framework. The gate would be constructed of steel square tubing weathered to appear rustic. Although primarily constructed of wood, the existing structure does contain metal elements; however the structure does not contain any features or components identical to the gate materials. The materials of the gate will be differentiated from the old, and will be weathered to appear rustic and compatible with the other historic materials. The gate will be placed in a secondary entry situated to the interior of the prominent front entry. The weathered components and placement of the gate will allow it to recede into the shadows and be less visible to the casual observer; the essential form and integrity of the property would remain unimpaired. No historic materials would be removed in the placement of the gate. The gate could be removed in the future without affecting the historic property or its environment.

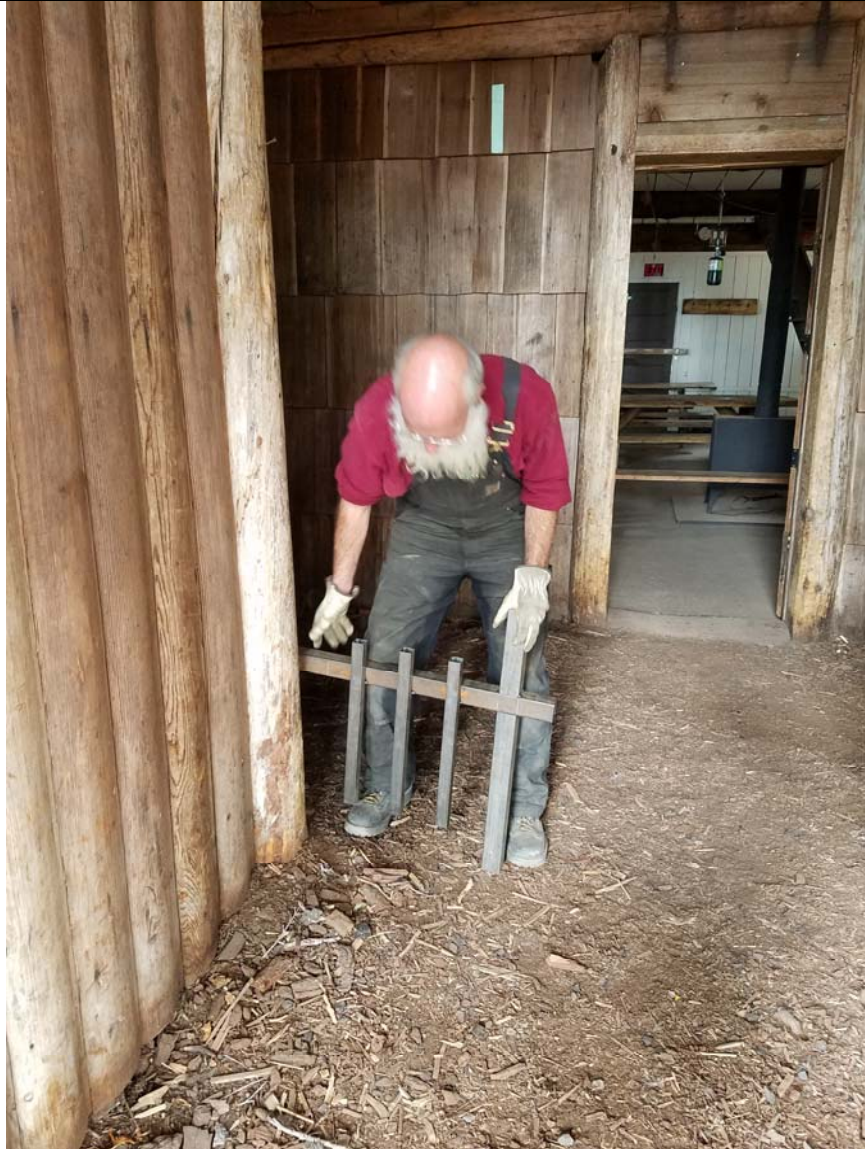
Figure 10. Proposed security gate design, placed in proposed location. Note that rustic color of proposed gate would blend in with the structure and environment. USFS digital photograph obtained by Michael D. Dryden 07/18/2016.

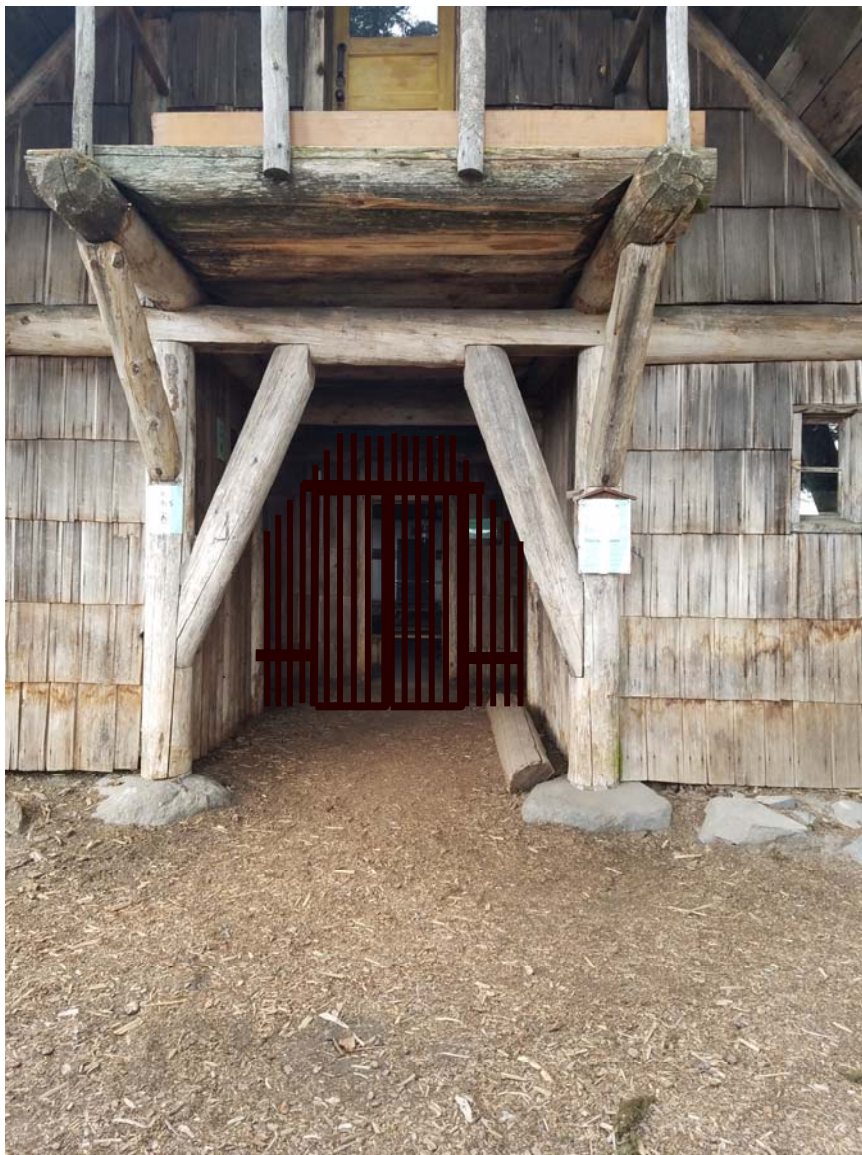
Figure 13. Conceptual drawing of security gate placement and color.
