RE: SHPO Case No. 16-1464
USFS, FS# 666EA0092A, Tilly Jane Ski Warming Hut
Preservation work on A-Frame
Forest Scervice Road 3512-630 (2S 9E 15), Hood River County

OREGON SHPO CLEARANCE FORM

A contributing element to the Cloud Cap-Tilly Jane Historic District, the Tilly Jane A-Frame, or Ski Warming Hut was constructed by the CCC's in 1939 and is the last addition to the Historic district. It is a one and one half story rectangular log A-frame building with a concrete foundation. It is on an east-west axis measuring 18 by 56 feet. The shake, gabled roof is built with log rafters that extend to the ground level forming the "A" shape. About half of these rafters are anchored on partially buried boulder abutments. The remaining foundations are concrete replacements installed in the early 1980's. The roof reaches the ground on the front 15 feet of the structure covering the vestibule. The exterior walls are all covered with shakes with the exception of the areas on either side of the vestibule, which are filled with vertical half-log siding (photo above). The fenestration of the building is regular, four-paned, fixed-wood sash windows. The exception to this is the nine-panel, fixed-wo

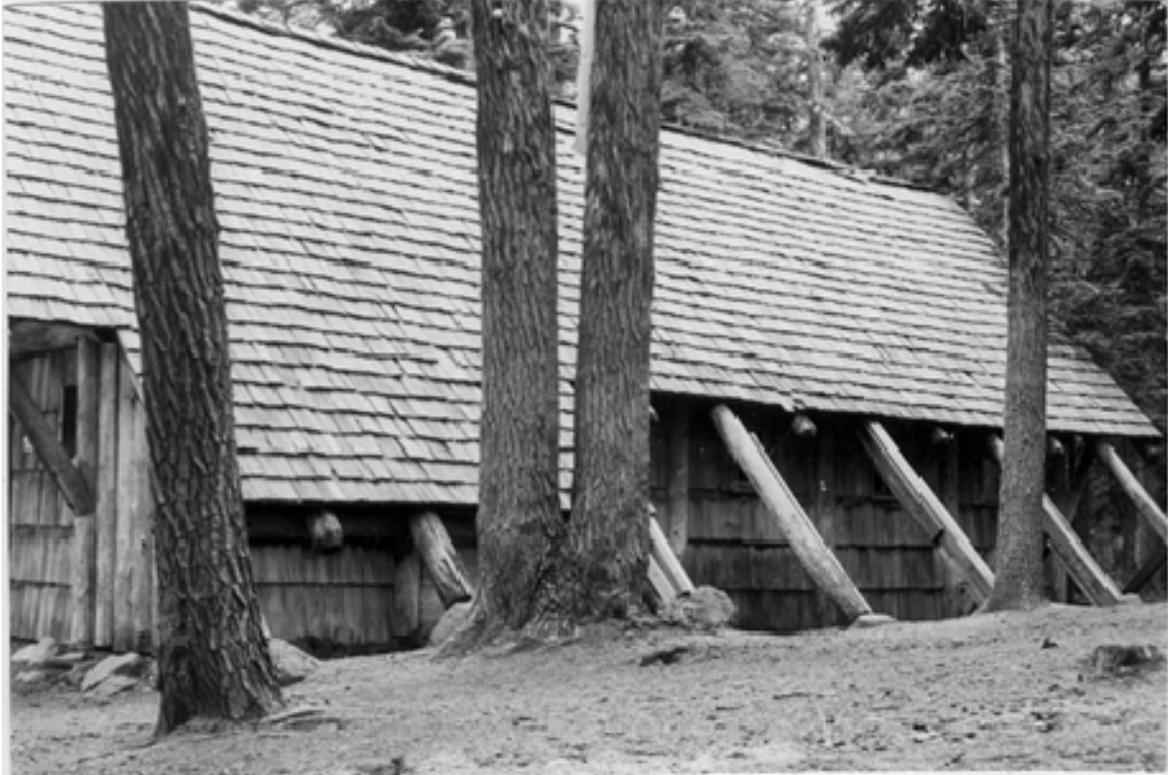
Figure 5. North elevation Tilly Jane Ski Warming Hut (A Frame). Undated USFS photograph.

Existing Condition: The A-frame shelter is in fair shape; however, the sleeping loft is showing signs of age and the supporting joists are on four-foot centers. The old loft floorboards and wide span results in sagging and a feeling of insecurity. The exposed portions of many of the buttresses have rotted. Some have been strengthened by the addition of 2x10 boards (Figures 10, 11 and 12). A modern door has been used to replace the balcony door on the main elevation. Of the two toilet areas in the original design, one is used for wood storage and the other is non-standard barrel toilet. A number of trees are growing next to the structure. Their branches are rubbing against the building resulting in abrasion and loss of shingles. Their roots have the potential to impact the buildings foundation. Many of the vertical support posts are in contact with the ground, and the bases of the posts show 4" to 10" of deterioration. Many of the exposed rafter and purlin ends are exposed to the elements and also exhibit decay. The north balcony shows varying degrees of deterioration, and the existing rail system is inadequate. Some of the exterior wall shakes show deterioration from ground contact and from birds boring for insects. All of the buttress/rafters on the north side have been replaced in the 1970s; the proposed project would replace non-historic materials on that side of the structure. The inspection of the structure by a regional Forest Service engineer Steven Oravetz revealed that all of the buttress/rafters on the south side of the structure have severely deteriorated and no longer retain any structural strength or stability and should be replaced.

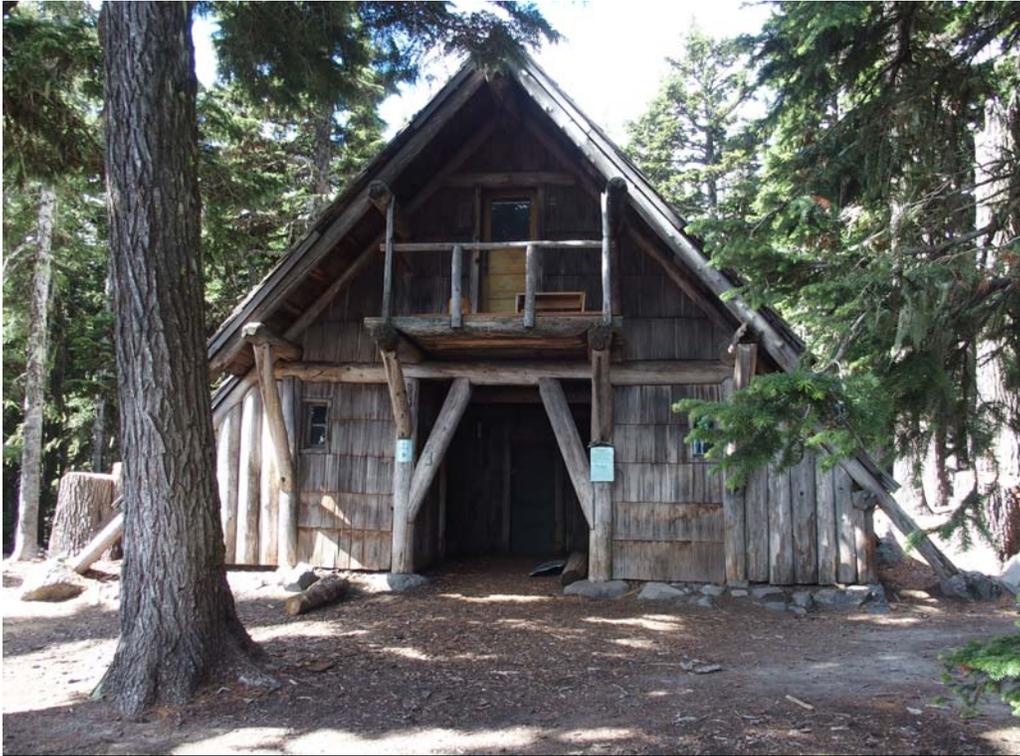
Figure 7. Tilly Jane Ski Warming Hut, east elevation (front). USFS digital photograph obtained by Michael D. Dryden 07/18/2016.

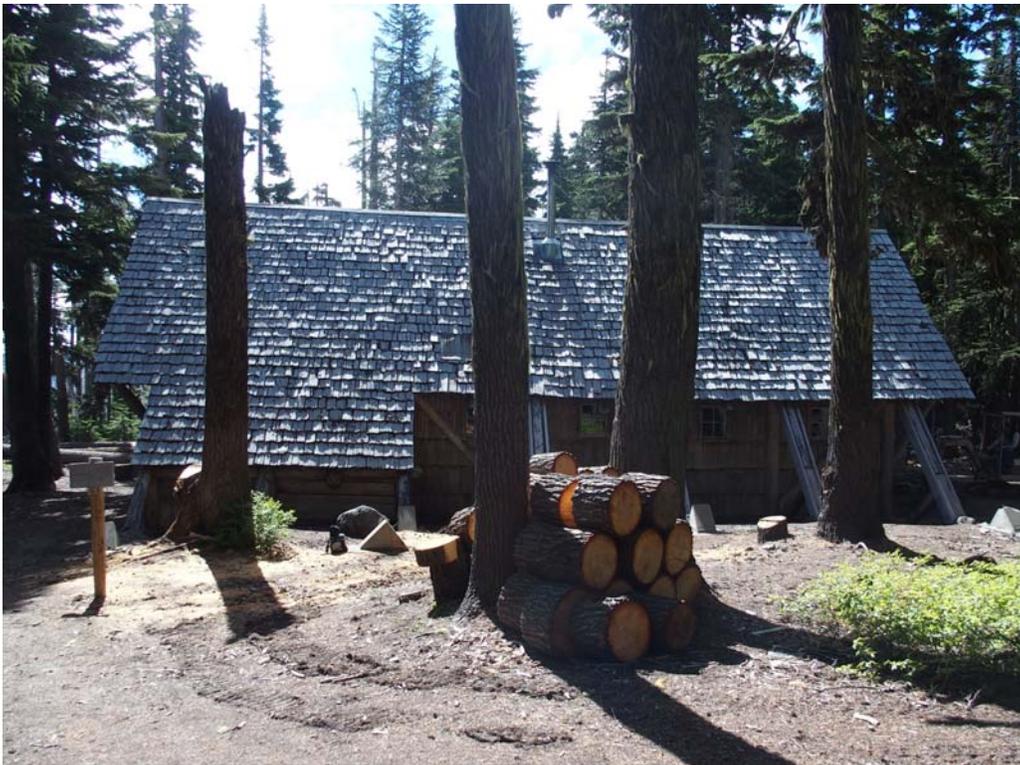
Figure 8. Tilly Jane Ski Warming Hut, south elevation. USFS digital photograph obtained by Michael D. Dryden 07/18/2016.

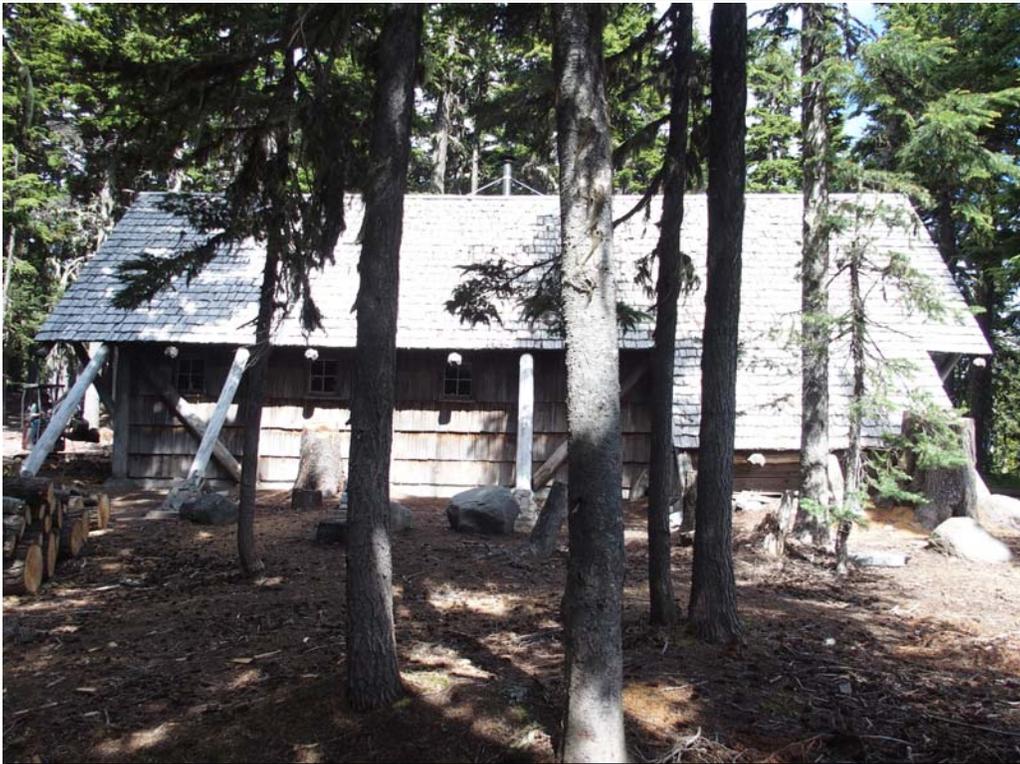
Figure 9. Tilly Jane Ski Warming Hut, north elevation. USFS digital photograph obtained by Michael D. Dryden 07/18/2019.

- The buttress/rafters on the north side of the structure have deteriorated significantly and lack structural integrity. These buttress/rafters will also be spliced up high under the eaves.

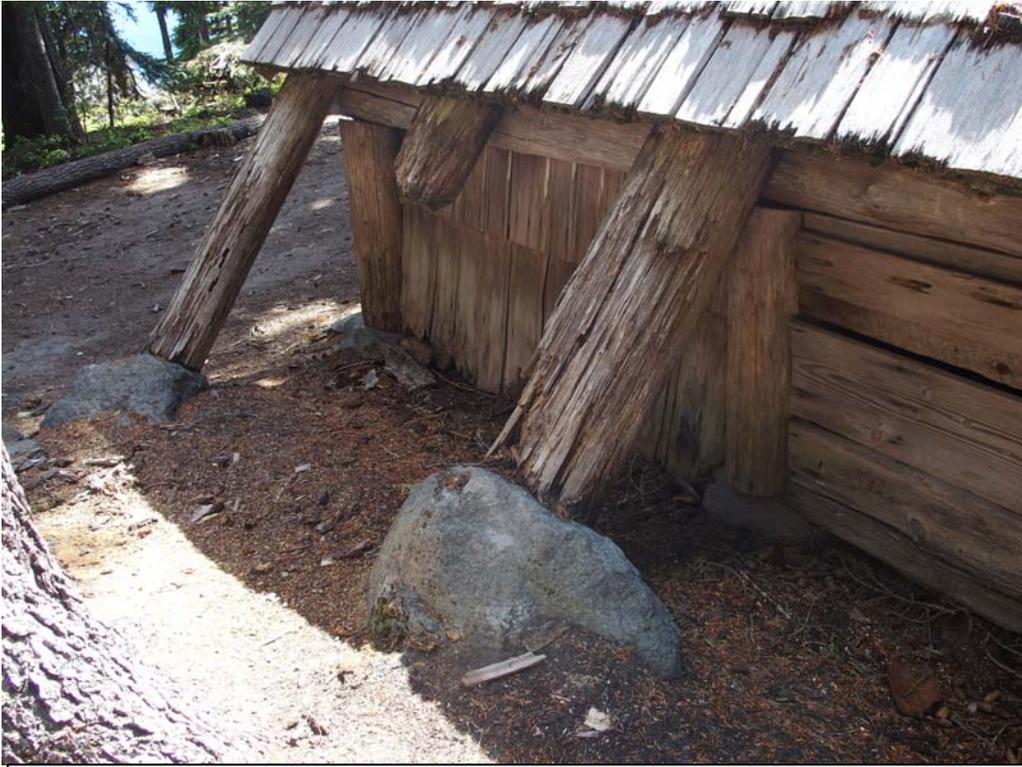
Figure 17. Tilly Jane Ski Warming Hut. View of intact original butters/rafter boulder anchors. USFS digital photograph obtained 07/18/2016 by Michael D. Dryden.

The buttress/rafter boulder anchors left in place on the north side of the structure were found to be solidly positioned and will be left in place. The project proposes to restore four of the buttress/rafter boulder anchors on the south elevation and to splice four replacement buttress/rafters on the north elevation (Figure 18).

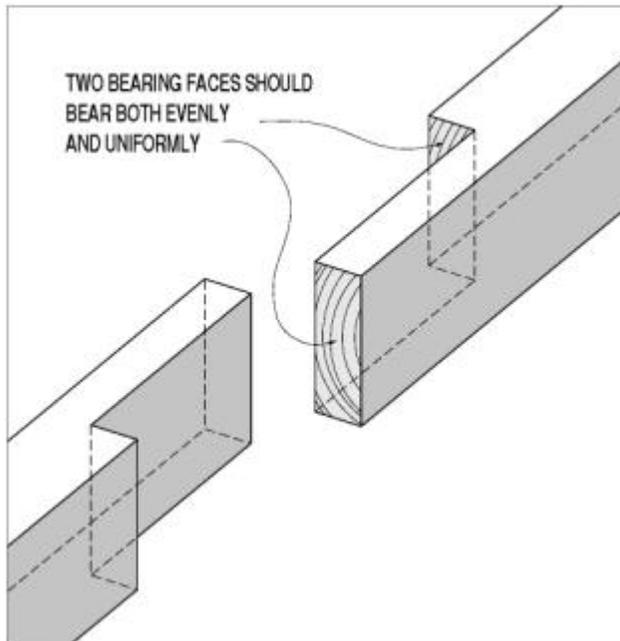
Figure 22. Example of half-lap splice.
<https://www.fhwa.dot.gov/publications/research/infrastructure/structures/04098/14.cfm>

- Logs of Pacific Silver Fir and hemlock would be selected for the appropriate diameter for half-lap splicing onto the original buttress/rafter (Figures 21 and 22).

- The replacement buttress/rafters would be secured with $\frac{3}{4}$ " bolts situated at the splice. The bolt heads would be counter-sunk to show less. The bolts would be an unobtrusive color, either black or rust-colored.
