Tilly Jane-Legion Camp Area: Many of the currently used public recreation facilities are part of this area. This portion of the Historic District was developed within the historic context of the Motor Age in the 1920's and 30's on the banks of Tilly Jane Creek. The development focused around a general public recreation use of the area. The Legion Camp on the east side of Tilly Jane Creek provided an annual sponsored, guided, climb of Mt. Hood that was open to the general public. The Tilly Jane campground was a free use campground open to the general public. The Tilly Jane Guard Station provided Forest Service presence during the recreation seasons. The Ski Warming Hut added by the CCC's provided winter accommodations for the general public, making the area usable year round. Only the southern foundation of the cableway across Tilly Jane Creek remains.

Tilly Jane A-Frame: A contributing element to the Cloud Cap-Tilly Jane Historic District.

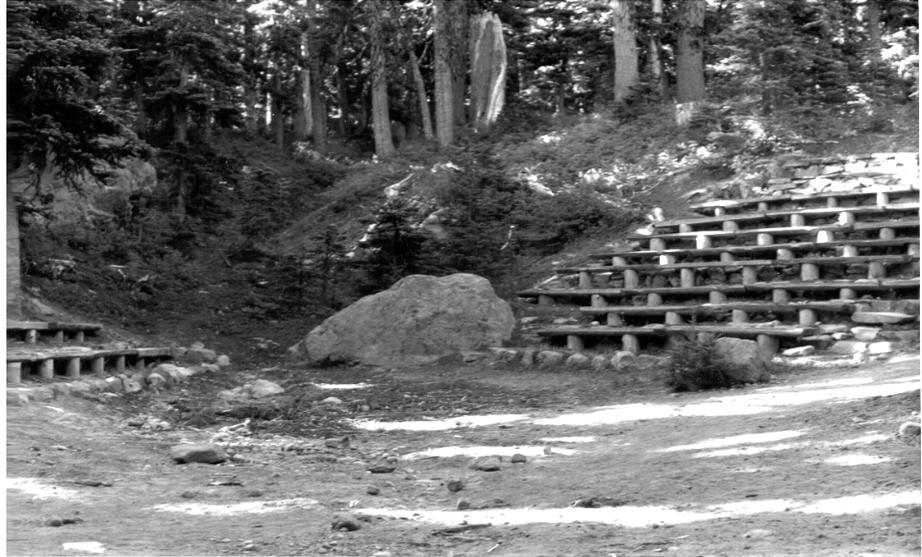
Existing Condition: This is an open-air amphitheater in good condition. The amphitheater underwent extensive renovation in 1989. The renovation consisted of the replacement of deteriorated half-round log bench seats. The replaced seats were anchored to the upright post supports using the same unique peg technique incorporated during the original construction.

Portions of the stone terraces and steps are collapsing and in need of repair.

Condition: The present character of the amphitheater should be preserved. The amphitheater was situated to take advantage of the views of Mount Hood; however, vegetation has matured over the last 40 years, blocking the original view of Mount Hood. The vegetation should be managed to restore and maintain the

view of the mountain to the southwest. A few of the trees adjacent to the amphitheater are suffering from the effects of insects and diseases. The condition of these trees should be assessed, and preservation or removal procedures should be prescribed.

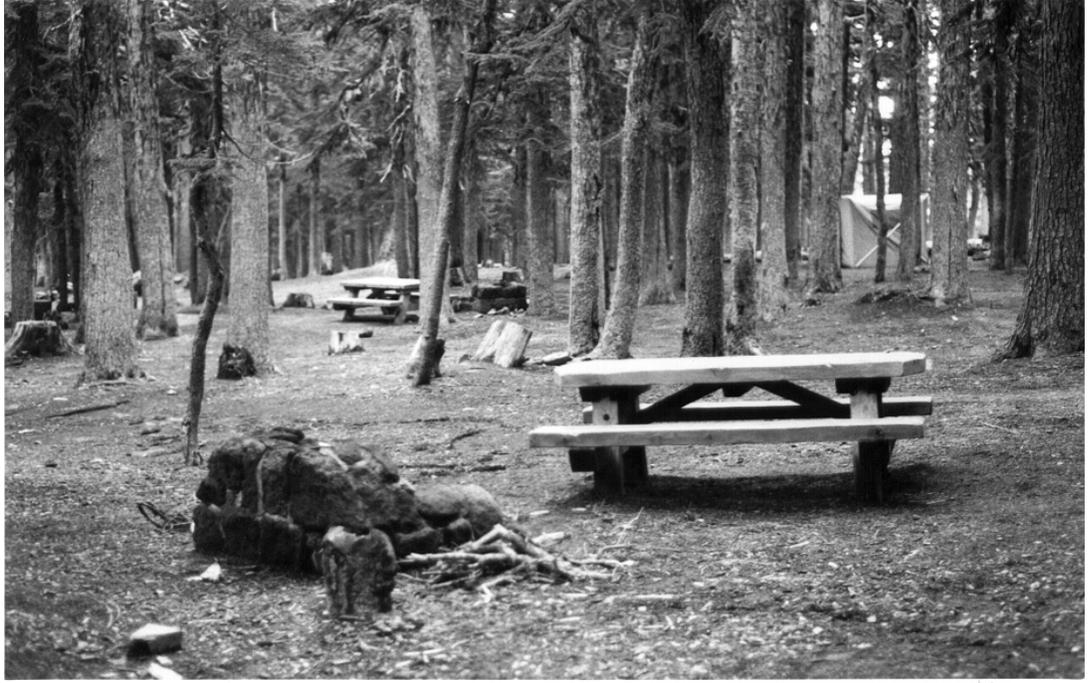
Existing Condition: In the 1980's, the campground was changed from drive up sites to walk-in sites by gating the roads. Ten of the fireplaces are still usable; six of these were repaired/reconstructed in 1996. There are five additional fireplaces that are in a deteriorated condition. None of them have grates. A few of the campsites have all metal “D” shaped fire pits, which detract from the historic character of the campground. A lack of visible campsite separators has resulted in extensive trampling of the understory vegetation. The original water system was abandoned twenty to thirty years ago; all water must be brought in or taken from Tilly Jane Creek. Every winter one or more trees blow over. In the 1995-6 winter, a tree blew down destroying one of the two toilets. A barrier free replacement was installed in 1977. None

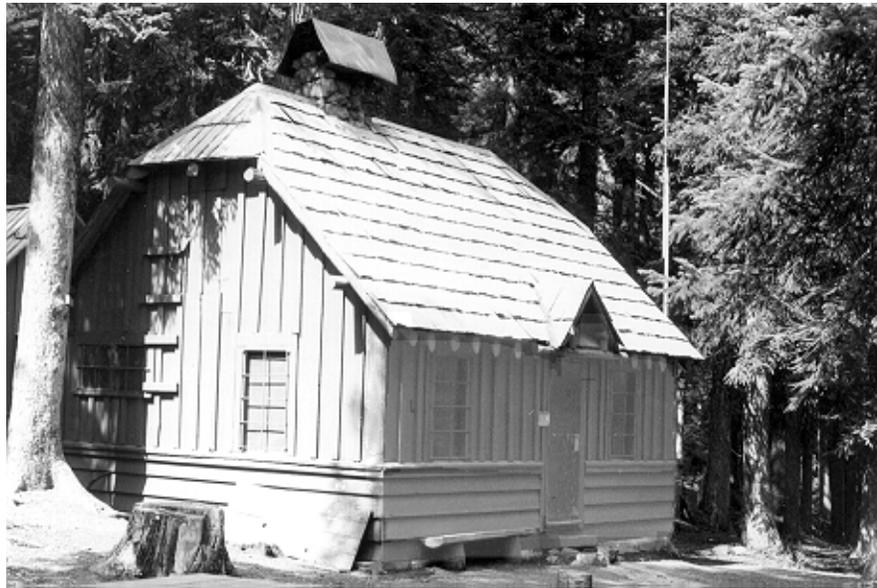
Existing Condition: The Guard Station is in good physical condition. The structure is in need of painting, and portions of the siding are in need of repair. Forest litter and debris, along with rain runoff tends to collect around the foundation of the structure. The northeast corner foundation of the garage is crumbling and needs to be repaired or replaced. Other needs include a chimney fire/spark screen and window screens.
